Bulletin for Statehouse, Capitol Mall Employees, November 18, 2004

Department of Administration  
Construction Update No. 45

## Contractors Filling in the Trenches This Week ... Efforts Being Taken to Minimize Noise, Disruption

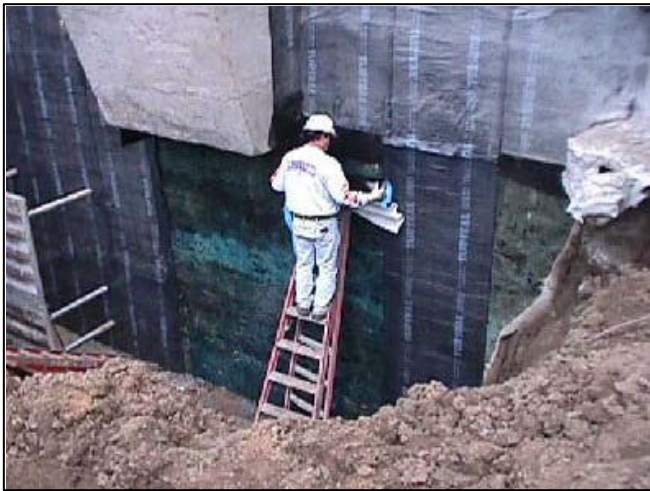
Worker checks waterproofing membrane placed on Capitol's exterior below ground level.

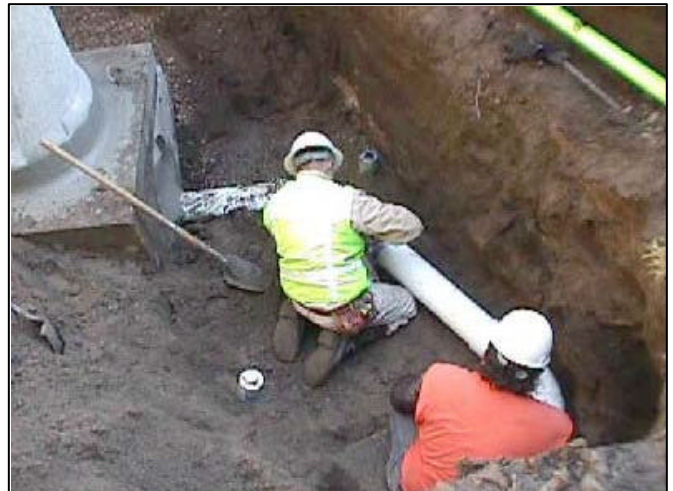
New drainage pipe is installed at the base of the foundation to protect against leakage.

The goal has been to make the drainage repairs before the wet and cold weather sets in. The work has been extensive due to the need for digging the soil to a **depth of about 10 feet right** next to the building to allow for the placement of drainpipe near the footings, and drainage fabric on the Capitol Building foundation walls.

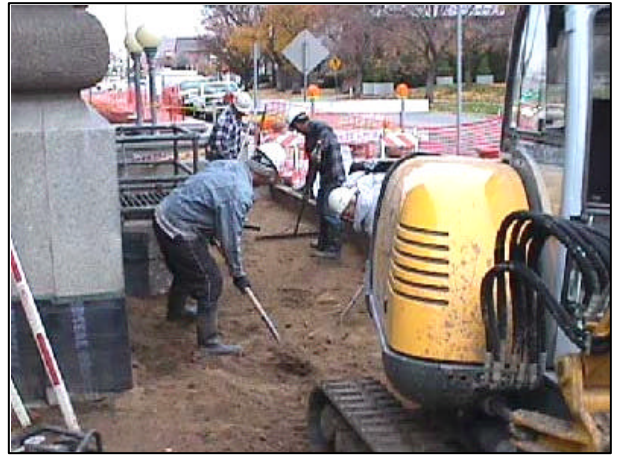
**Workers prepare area for drainage repair  
on the Capitol's State Street side.**
